# Memo

Re: ACTION RE: CERTIFICATE OF APPROPRIATENESS REQUEST TO RAZE A LOCALLY DESIGNATED HISTORIC LANDMARK – THE MONUMENT COMMEMORATING THE SITE OF THE FIRST COURTHOUSE IN WISCONSIN LOCATED AT HERITAGE HILL STATE PARK (2640 S. Webster Avenue)

# Heritage Hill State Historical Park

## **Condition Summary of the Granite courthouse Monument** (performed in August 2021)

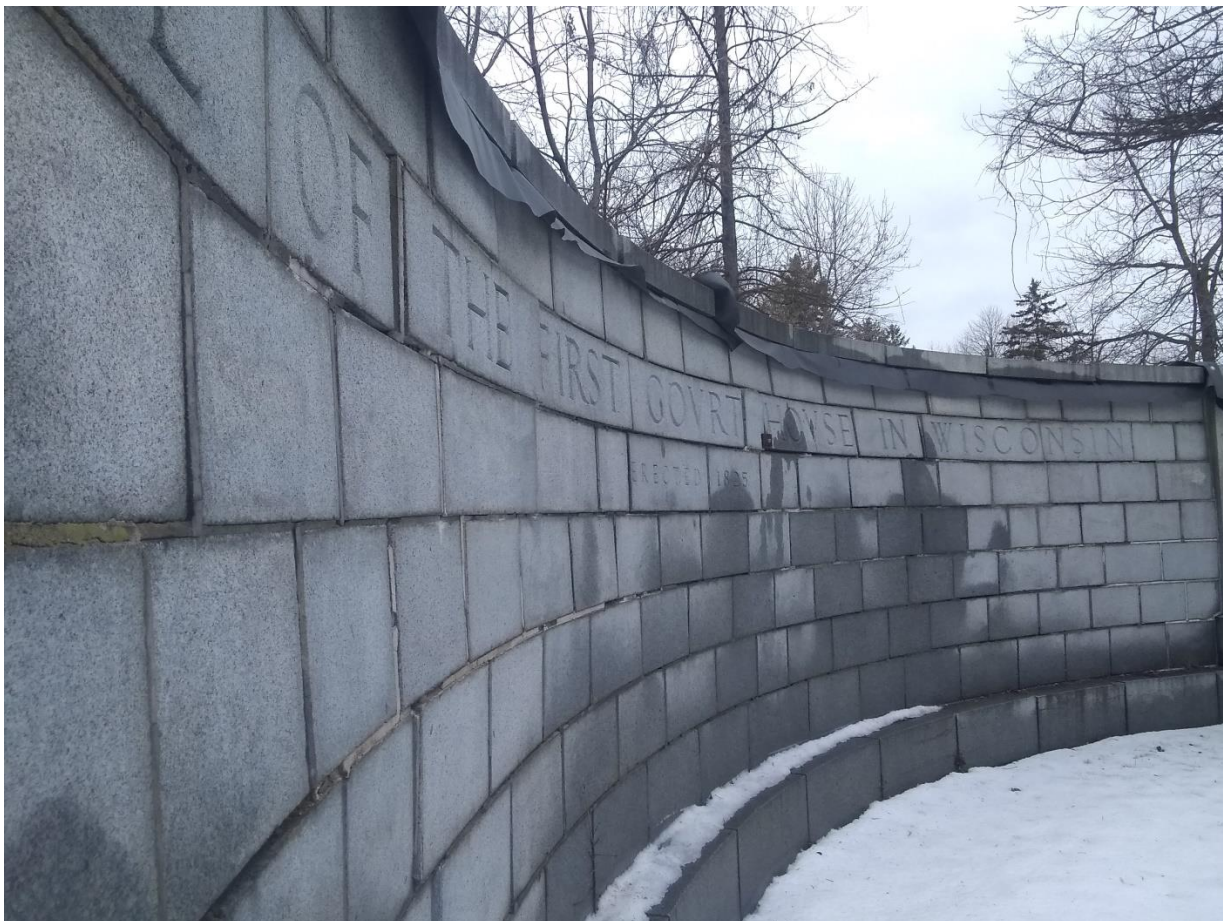
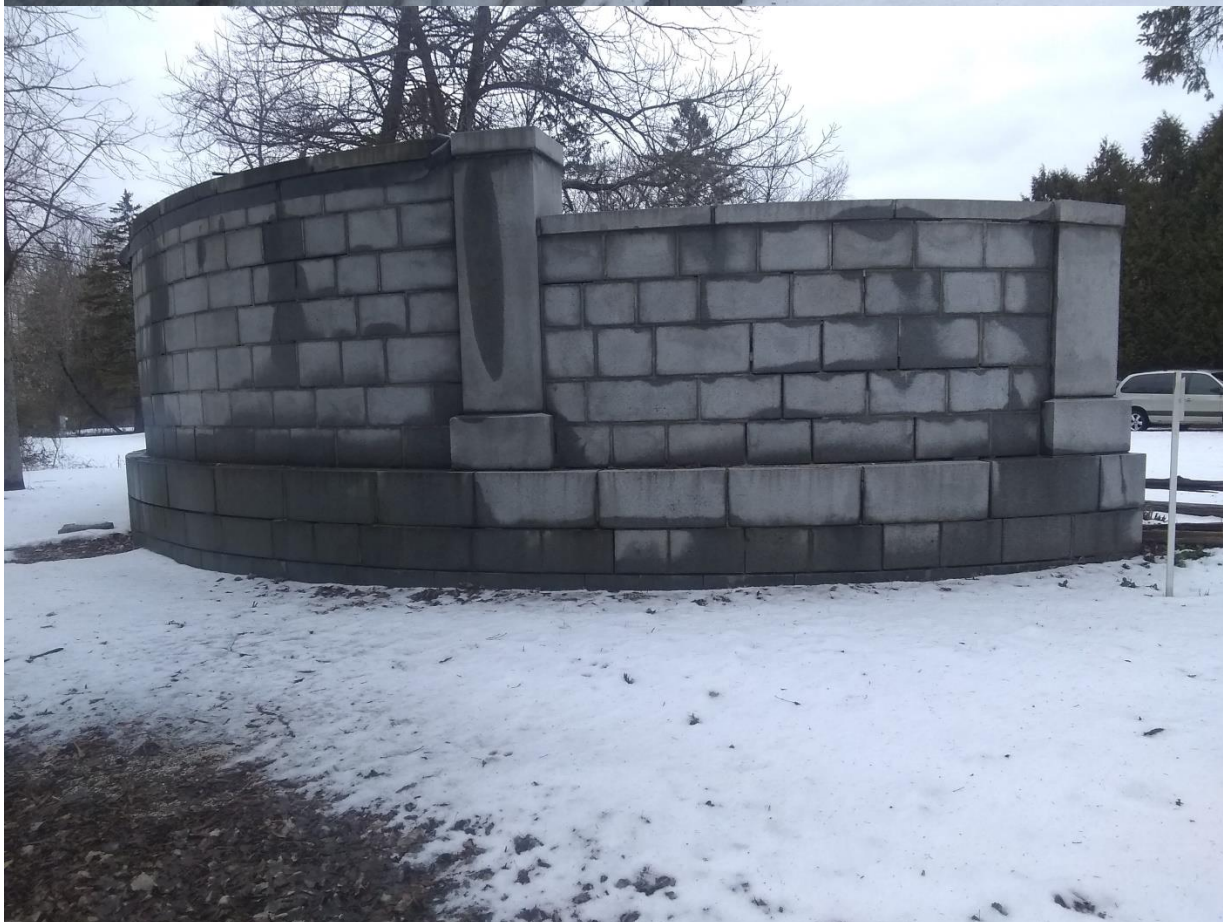
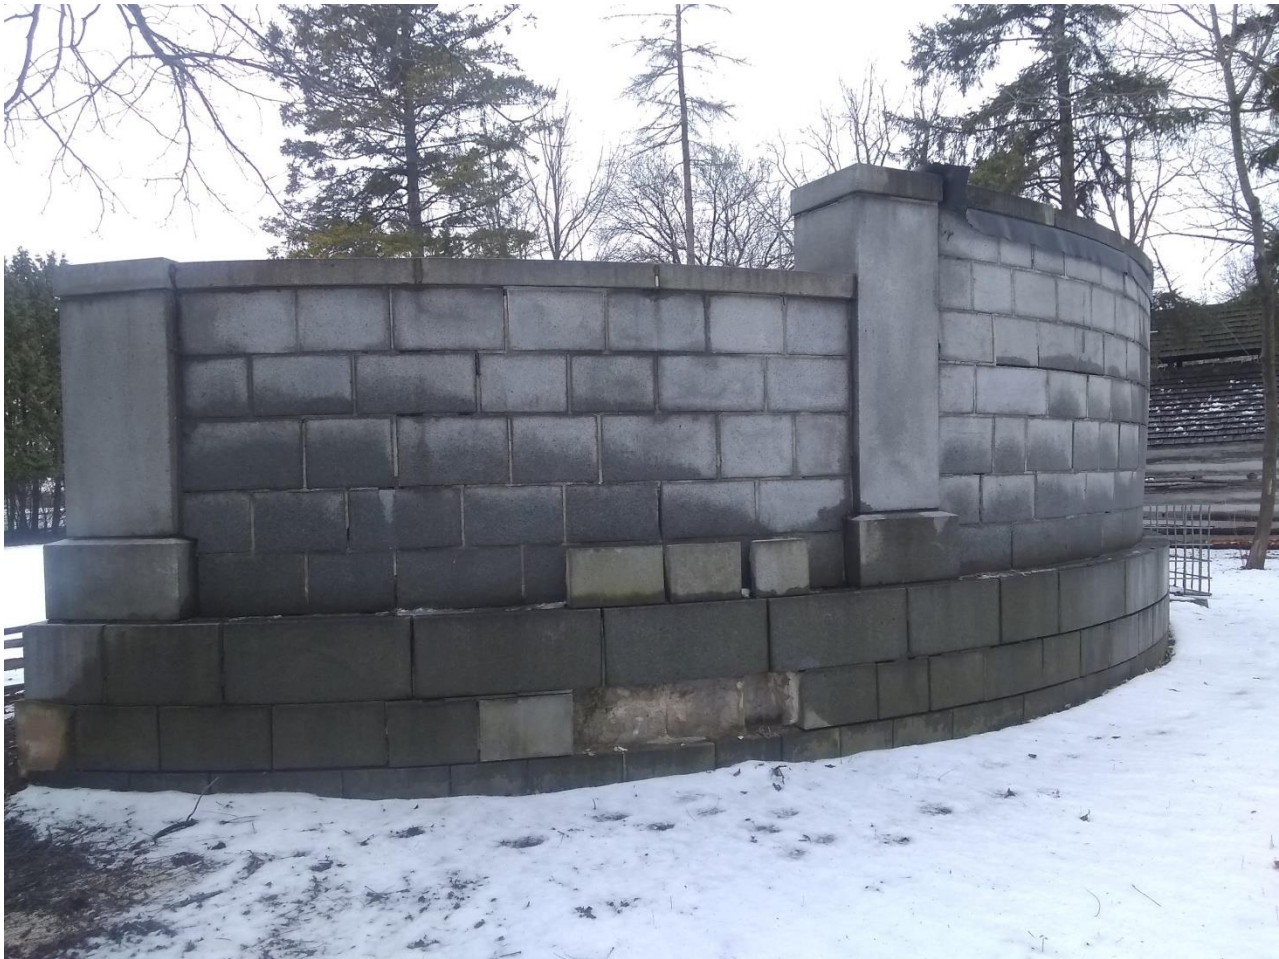
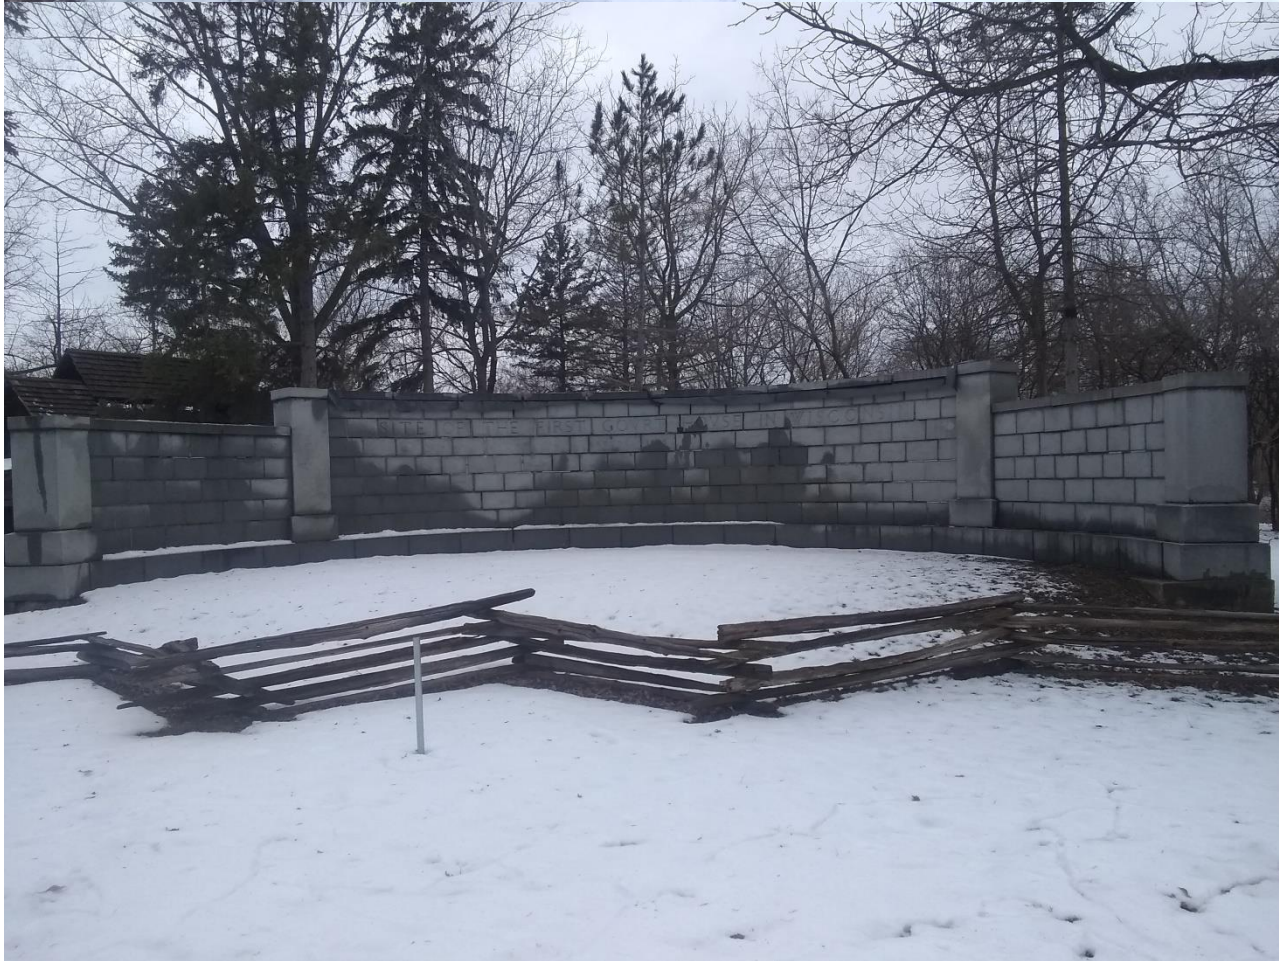
Ten of the top cap stones in the center section of the monument were removed to gain access into the space between the front and back faces of the monument. The front and back face stones are approximately six inches thick each with a twelve-inch space between the two. The space was filled with various materials including pieces of granite (cast-off pieces from the construction), brick, mortar, and concrete. Many areas of this rubble were capped with poured in mortar as a method to lock the commingled materials together for stability. Further investigation of a wide diagonal stepping mortar joint on both the front and back faces of the center portion revealed the concrete foundation had cracked and separated. Excavation of the foundation on the back of the monument showed that the concrete was formed and poured in a way frost had been pushing and stressing the foundation. General advanced deterioration and widening of the mortar joints on both the front and back faces exist throughout, resulting in the noticeably large bulges and shifting face blocks, this is especially noted in the center section of the monument. The “book end” columns that frame the Center, North and South walls have been affected by freeze thaw cycles also, resulting in an out of plumb condition of the four columns as well as the increased overall length of the monument.

Failed mortar joints allowed water penetration into the interior of the monument. Over an extended period of time, much of the rubble had settle downward through the freeze thaw cycles making the re-alignment of the bulging front and back walls not Possible without the total disassembly and reassembly of the Monument. The inherent design flaw of the foundation would require its removal and the installation of a new structurally enhance foundation.

Heritage Hill’s Building and Grounds committee consulted with RJ Jacques Inc. A restoration company specializing in masonry (1710 Steffens Way Green Bay) R.J. Jacques recommended a full disassembly with a new foundation as the appropriate long-term repair.

Estimated cost to restore: \$150,000.00 -\$200,000.00.
