Memo

Re: ACTION RE: CERTIFICATE OF APPROPRIATENESS REQUEST TO RAZE A LOCALLY DESIGNATED HISTORIC LANDMARK – THE MONUMENT COMMEMORATING THE SITE OF THE FIRST COURTHOUSE IN WISCONSIN LOCATED AT HERITAGE HILL STATE PARK (2640 S. Webster Avenue)

Condition Summary of the Granite courthouse Monument (performed in August 2021)

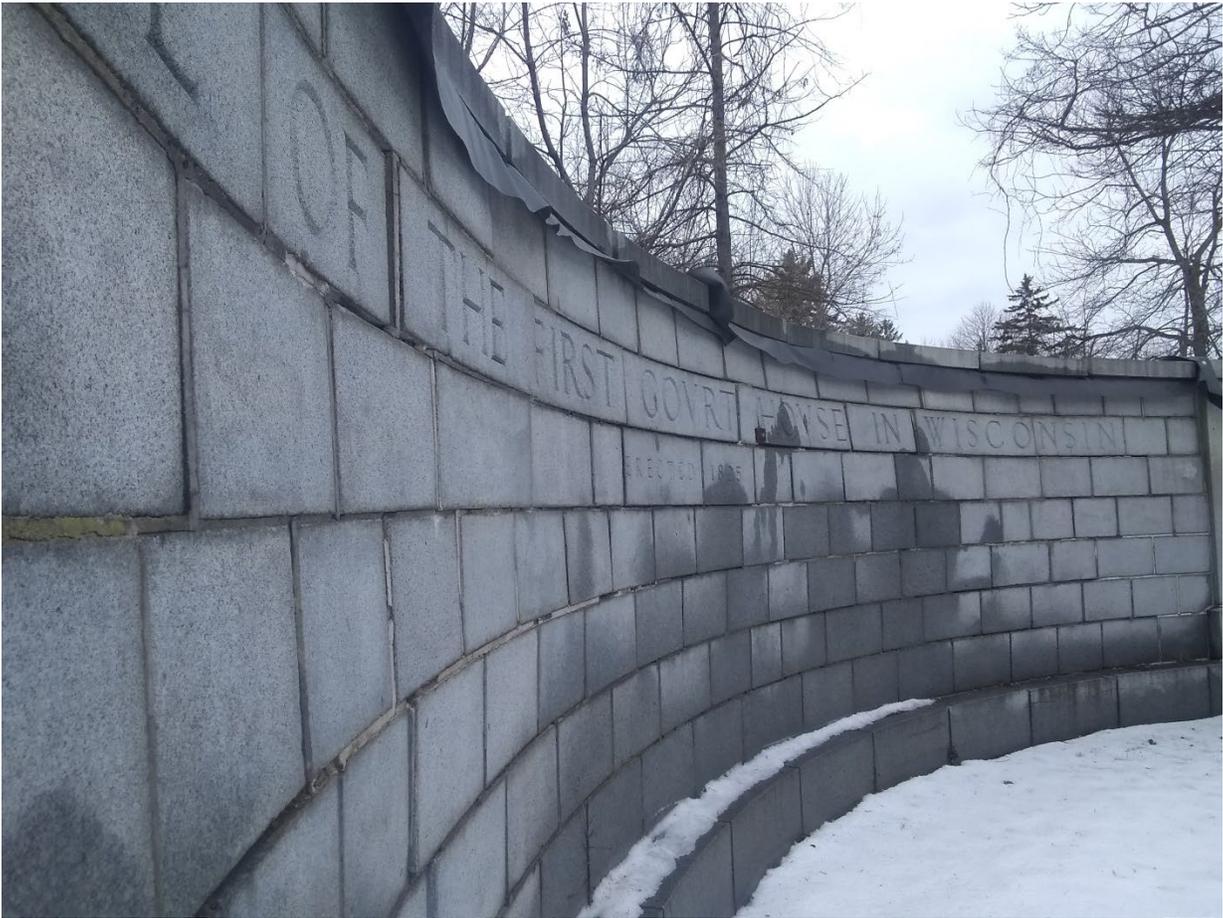
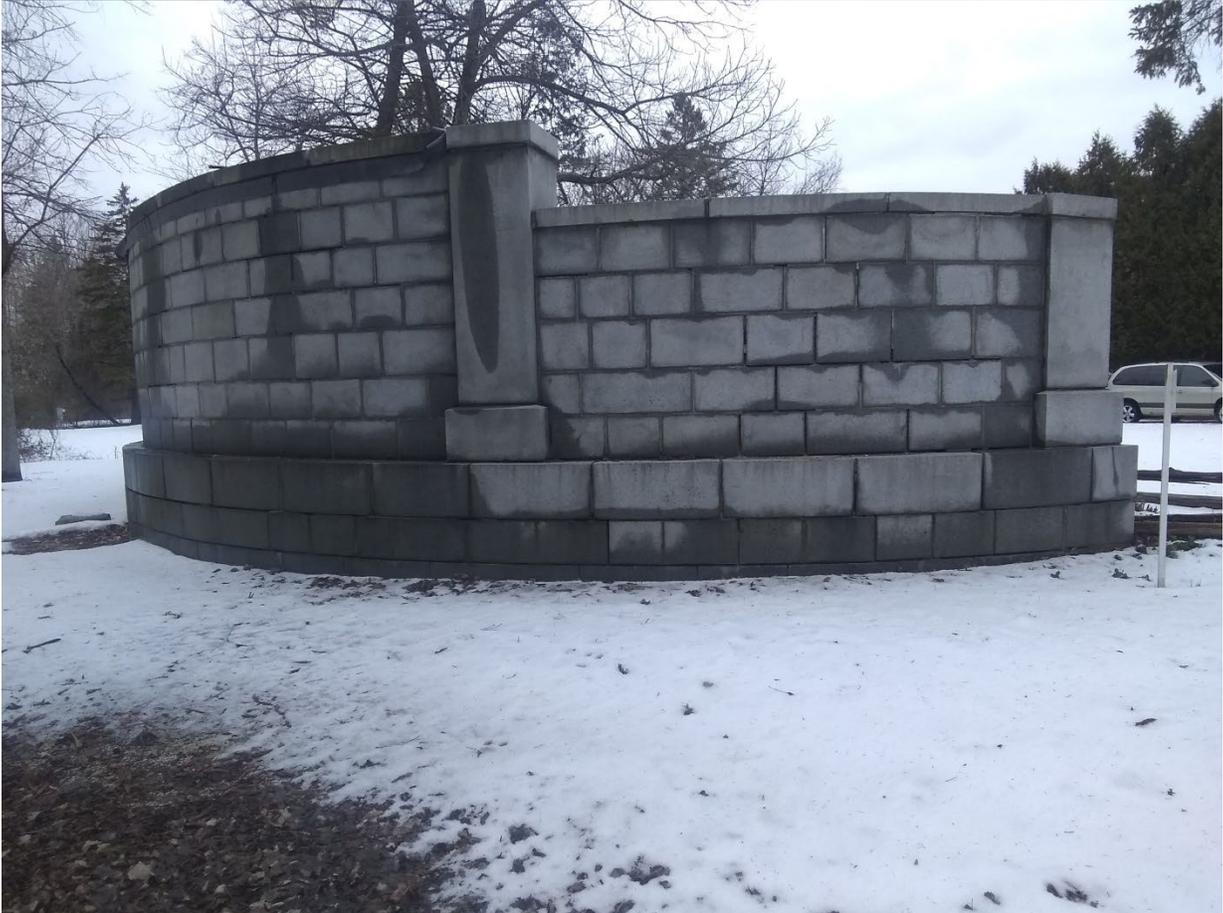
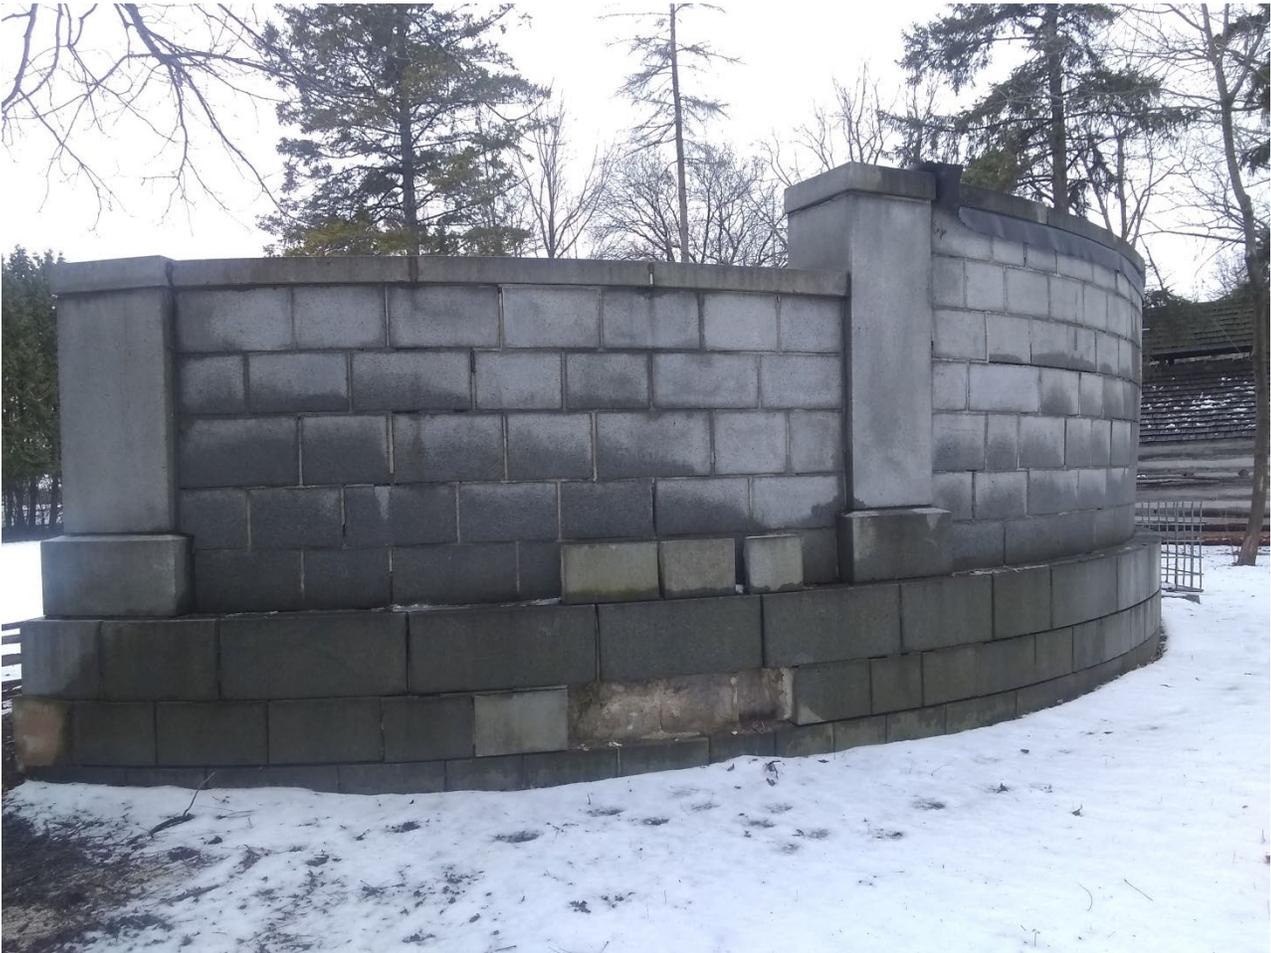
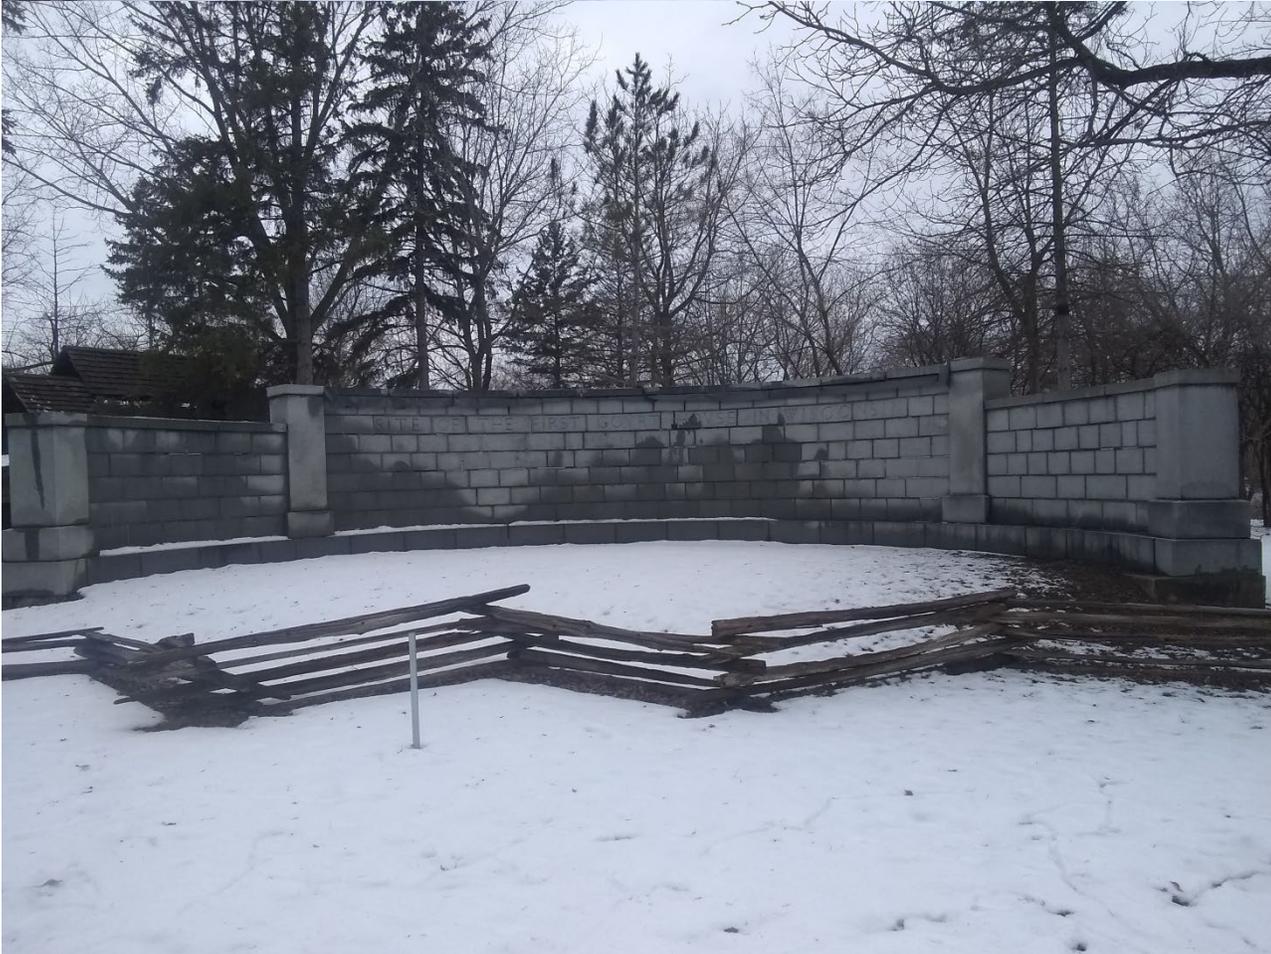
Ten of the top cap stones in the center section of the monument were removed to gain access into the space between the front and back faces of the monument. The front and back face stones are approximately six inches thick each with a twelve-inch space between the two. The space was filled with various materials including pieces of granite (cast-off pieces from the construction), brick, mortar, and concrete. Many areas of this rubble were capped with poured in mortar as a method to lock the commingled materials together for stability. Further investigation of a wide diagonal stepping mortar joint on both the front and back faces of the center portion revealed the concrete foundation had cracked and separated. Excavation of the foundation on the back of the monument showed that the concrete was formed and poured in a way frost had been pushing and stressing the foundation. General advanced deterioration and widening of the mortar joints on both the front and back faces exist throughout, resulting in the noticeably large bulges and shifting face blocks, this is especially noted in the center section of the monument. The “book end” columns that frame the Center, North and South walls have been affected by freeze thaw cycles also, resulting in an out of plumb condition of the four columns as well as the increased overall length of the monument.

Failed mortar joints allowed water penetration into the interior of the monument. Over an extended period of time, much of the rubble had settle downward through the freeze thaw cycles making the re-alignment of the bulging front and back walls not Possible without the total disassembly and reassembly of the Monument. The inherent design flaw of the foundation would require its removal and the installation of a new structurally enhance foundation.

Heritage Hill’s Building and Grounds committee consulted with RJ Jacques Inc. A restoration company specializing in masonry (1710 Steffens Way Green Bay) R.J. Jacques recommended a full disassembly with a new foundation as the appropriate long-term repair.

Estimated cost to restore: \$150,000.00 -\$200,000.00.
